Summer 2006 Black Fallout Incidents in the City of Hamilton

Report of Findings

Ministry of the Environment

Analysis of Wind Data for July 30 Hamilton Black Soot Incident and Subsequent August Incidents

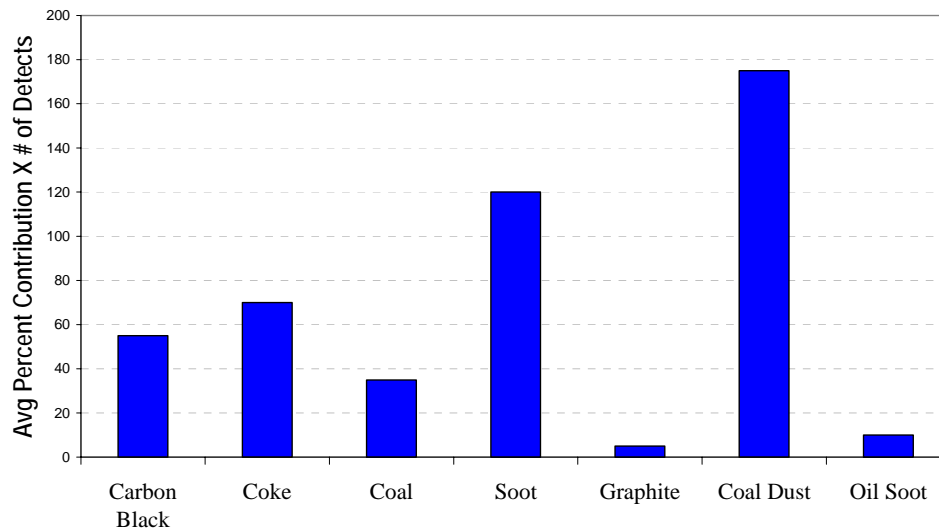
**Relative Abundance of Carbons in 18 Complaint Samples
July 30 and Aug 10-11**

The fallout samplings included carbon black from 5-20%, coke 5-20%, coal 5-20%, soot 5-20%, and coal dust 5-30%, in samples where detections occurred.

The prominent presence of coal and coal dust indicates that long-term accumulations of particles masked the presence of new fallout in the events of July 29-30 which were caused by stack emissions, not fugitive ones such as coal piles.

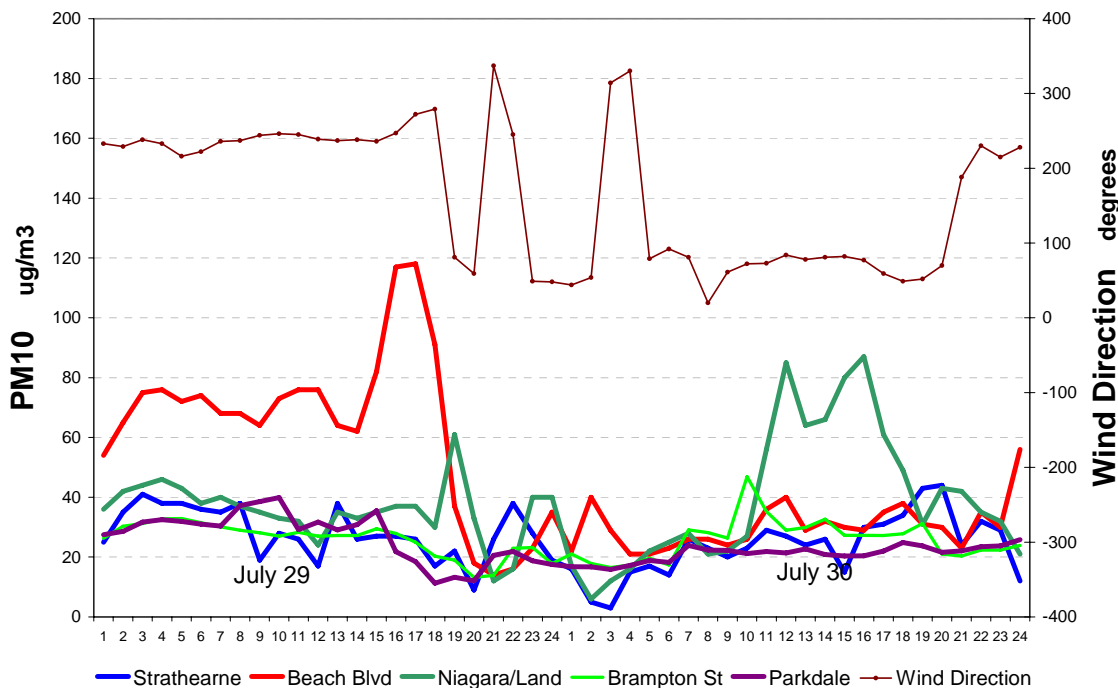
Hourly Particulate (PM10) Readings During Event

There were 5 continuous particulate monitors operating during the initial fallout event on the weekend of July 29-30. The following displays the hourly PM₁₀ concentrations measured:

The three numbered stations belong to the HAMN monitoring network which is operated by consultants for local industries. The two “G” samplers were MOE samplers which were in the midst of a short term monitoring survey in the area. There were no strong peaks measured during the two days except for one two hour event at 29102- Beach Blvd just before the wind shifted from west/southwest to northeast on the 29th. Hourly PM₁₀ levels of 118 and 117 $\mu\text{g}/\text{m}^3$ were measured. However, there were no fallout complaints from the station area and this level of concentration is routinely measured at this station during these wind directions without complaints being received. The peak may possibly be related to the black fallout event, but likely it is not. It should be noted that some of these instruments may be subject to some interferences and other technical limitations which may not always allow them to detect particle fallout. Because of these findings there is no quantitative assessment of the amount of fallout materials that fell on the area. All findings are qualitative in nature.

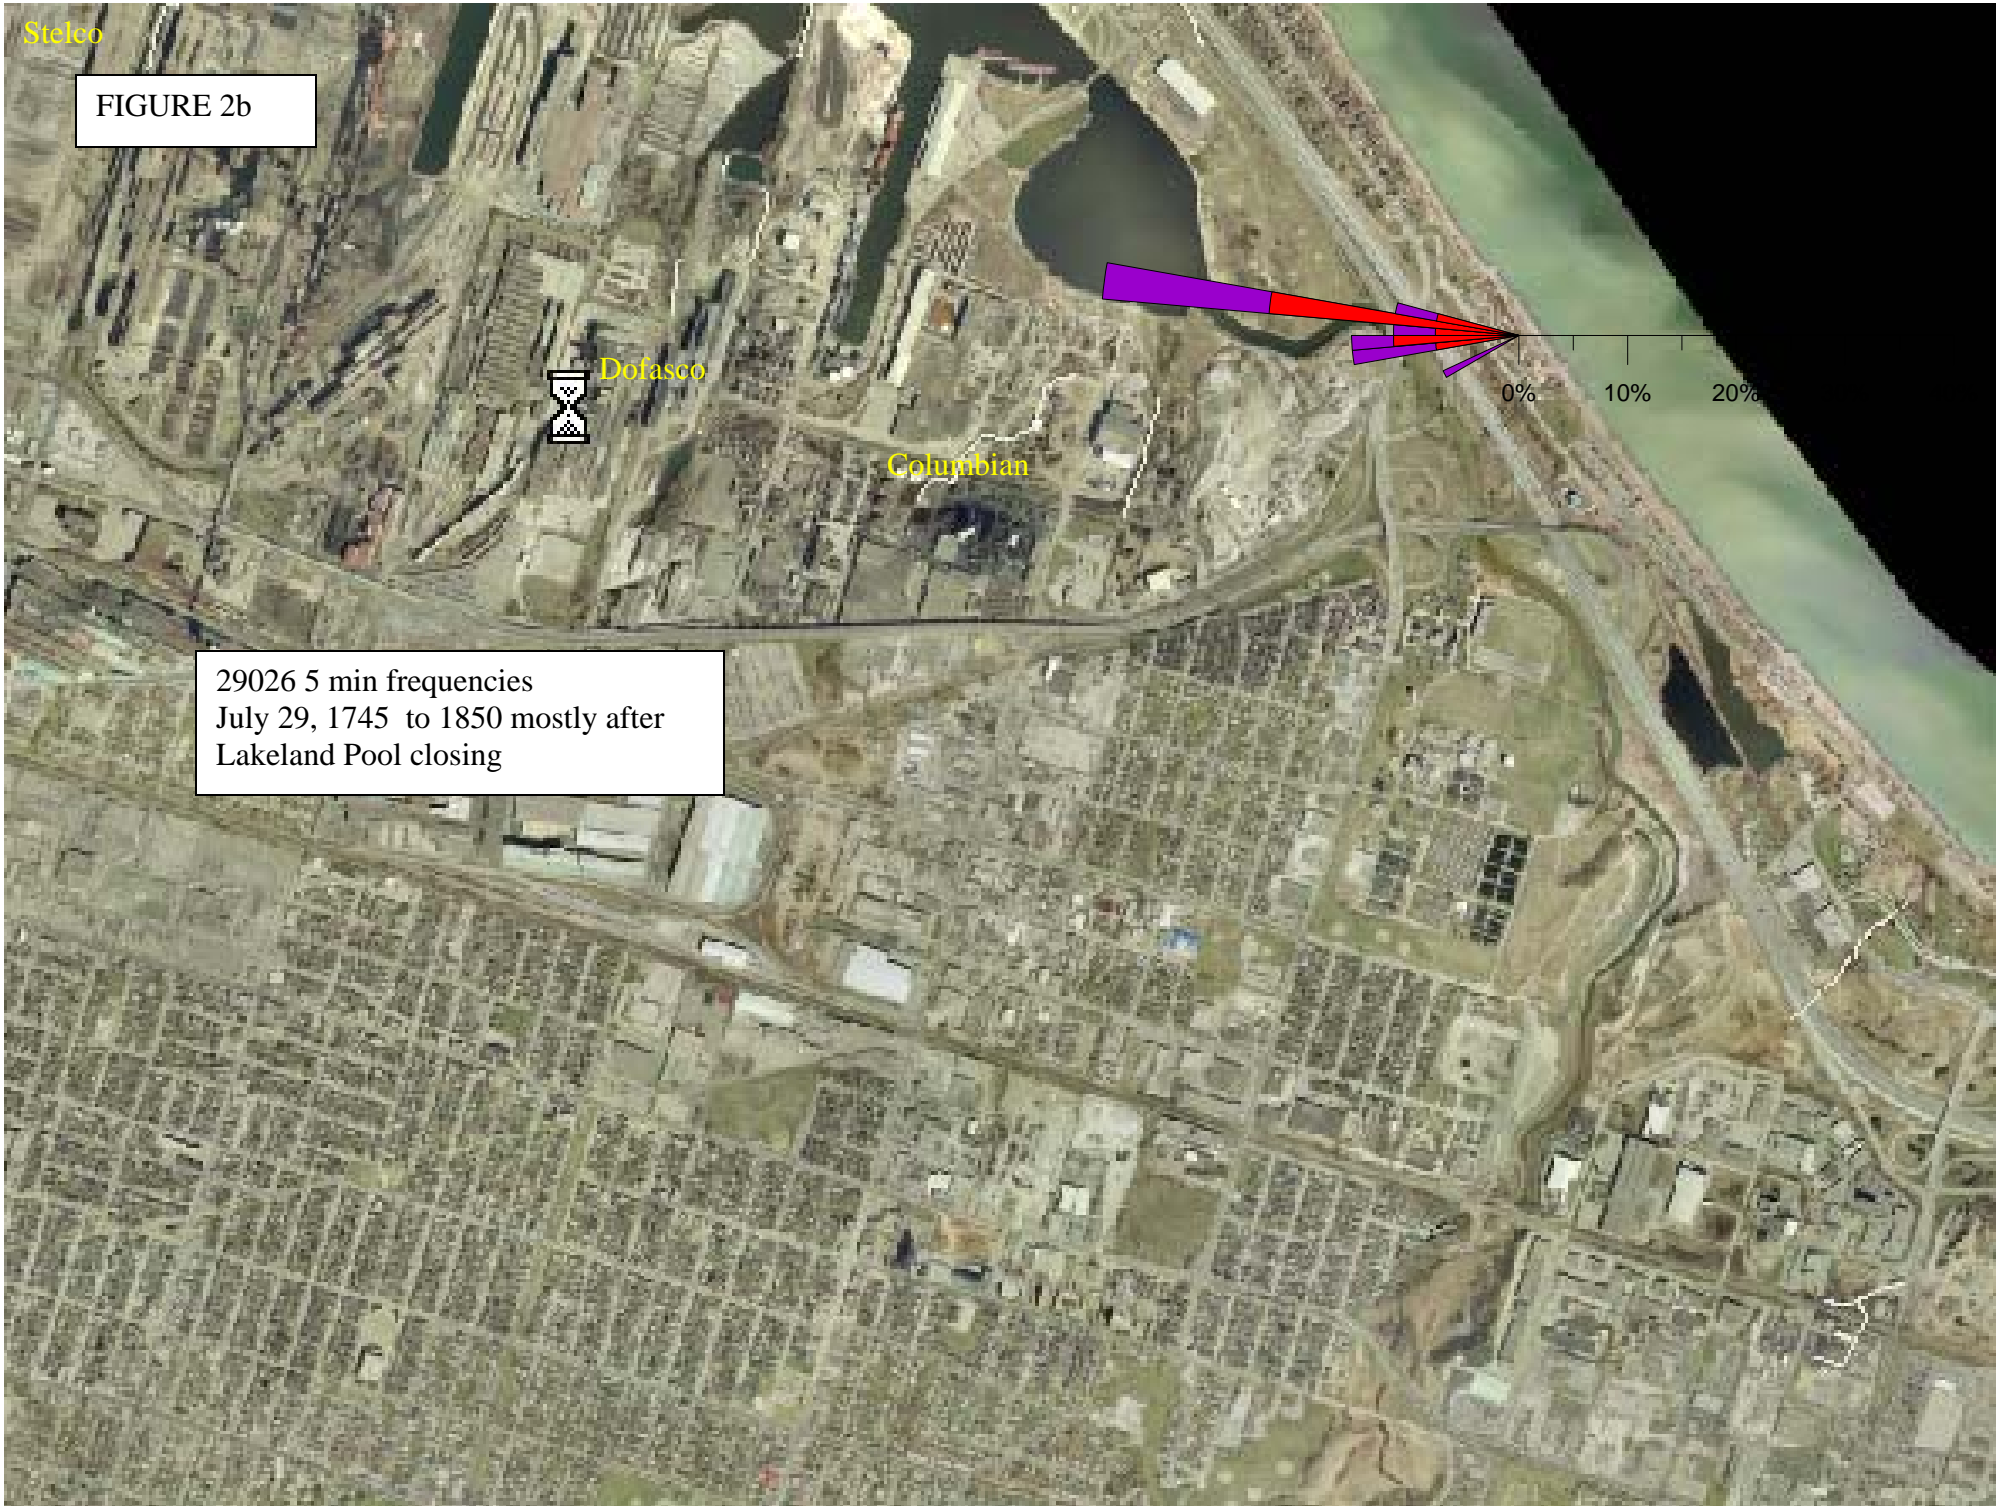
FIGURE 2b

Also in Figure 2a is a rose for the period from July 28/29 when winds were from the southwest blowing almost directly from Columbian to Lakeland Pool. There were no dust complaints noted at the pool during Saturday, which was well attended (Hamilton Conservation Authority consulted). Figure 2b shows the wind rose for just the Saturday period of 1745 (just before pool closing) to 1850 when the winds shifted. The rose points mostly westerly and west southwest, indicating potential for both Dofasco and Columbian as sources. The Lakeland Pool observations were only called in to the Ministry on Aug 3rd after extensive publicity of the fallout problem. It is unknown if fallout was present earlier Saturday during opening hours and was either not observed or not seen as a problem by the people there.

29026 5 min frequencies
July 29, 1745 to 1850 mostly after
Lakeland Pool closing

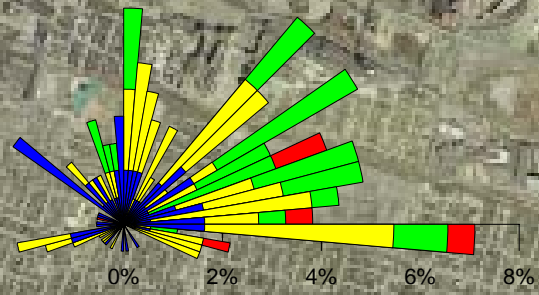
FIGURE 3

The same Woodward rose as in Figure 2a is placed onto this address in Figure 3 and points at Columbian, Dofasco and Stelco. The northwest wind bars are not as reliable due to low wind speeds.

29026-Woodward 5 min frequencies
July 29, 1800 to July 30, 1000
Rosslyn Ave

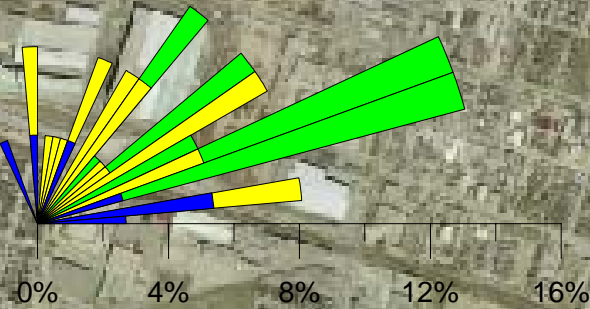
FIGURE 5

The caller advised they had cleaned up the original fallout on July 30th and now it was back on the 31st. Winds remained northeast only until 1900 on the 30th so a rose was prepared for a 3 hour period from 1600-1900 in Figure 5. The rose points most strongly at Columbian with smaller wind frequency from Dofasco.

29026-Woodward 5 min frequencies
July 30, 1600 to 1900 after cleaning
Strathearne Ave N

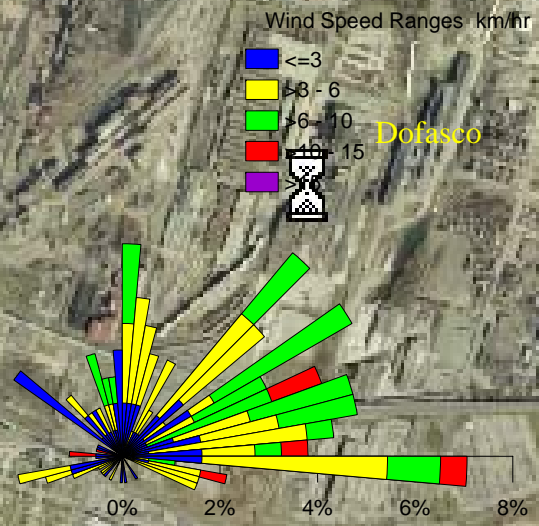
FIGURE 6

The same Woodward rose as in Figure 2a is placed onto this address in Figure 6 and points at Columbian, Dofasco and Stelco. The northwest wind bars are not as reliable due to low wind speeds.

29026-Woodward 5 min frequencies
July 29, 1800 to July 30, 1000
Roosevelt Ave

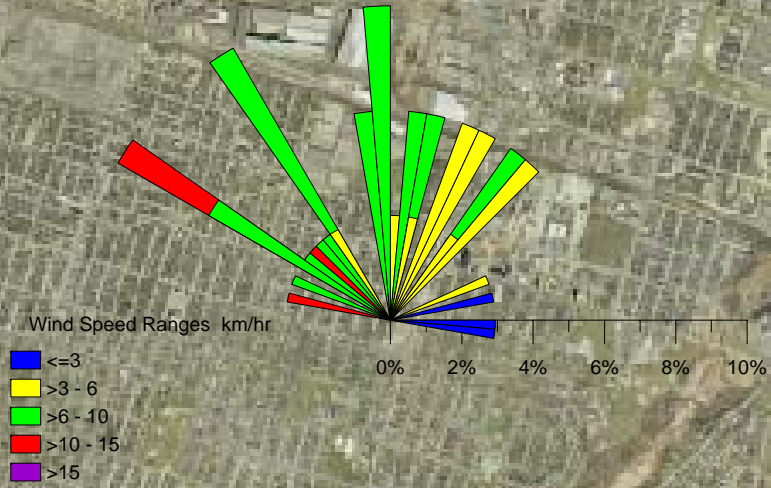
FIGURE 7

The caller advised they had cleaned up the original fallout from July 30th and now it was back on the Aug 3. Winds became northwest, then northeast only 5 hours previous to the call and a rose was prepared for the period from 0500-1000 in Figure 7. The rose points at Columbian, Dofasco and Stelco.

29026-Woodward 5 min frequencies
Aug 3, 0515 to 1000 after cleaning
Glennie Ave

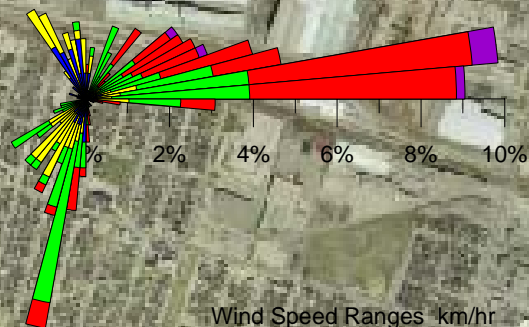
FIGURE 8a

The caller advised of a new soot fallout event on Aug 10. This address was part of the original complaints. Winds had been from the northeast off and on since Aug 8 and Figure 8a displays the wind rose for this extended two day window. It points at Columbian, Dofasco and Stelco. A rose in Figure 8b depicts the conditions for the last distinct northeast wind period which occurred prior to the call and it points exclusively at Columbian.

29026-Woodward 5 min frequencies
Aug 8, 0900 to Aug 10, 0900 second soot event
Fairfield Ave

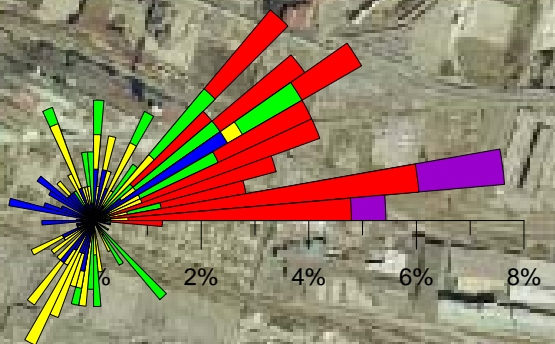
FIGURE 11

The callers advised of shiny particle fallout on Aug 13, which are presumed to be kish. Winds had been northeast for the previous 24 hours and the wind rose in Figure 11 points at Dofasco and Stelco.

29026-Woodward 5 min frequencies
Aug 12, 1200 to Aug 13, 1400 shiny particles
McAnulty Blvd

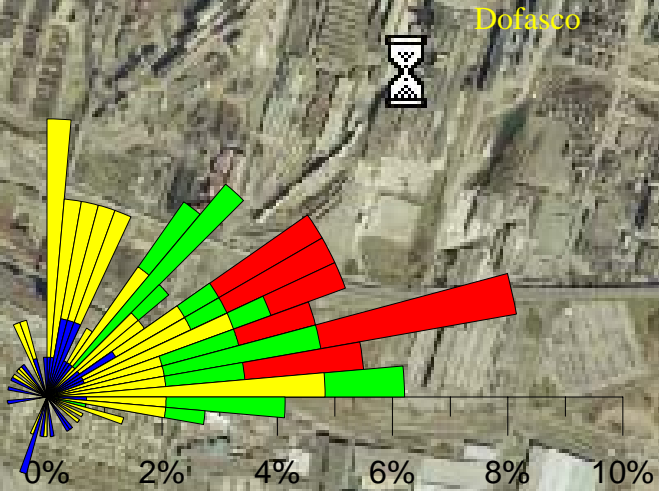
FIGURE 12

The caller advised of soot fallout on Aug 19 on his vehicle. Winds had been north or northeast since midnight and the wind rose in Figure 12 points at Dofasco and Columbian.

The caller advised of soot fallout on Aug 19. Winds had been north or northeast since midnight and the same wind rose as previous item in Figure 12 points at Dofasco and Columbian.

29026-Woodward 5 min frequencies
Aug 19, 0000 to 1200 soot fallout
Benson Ave and McAnulty Blvd

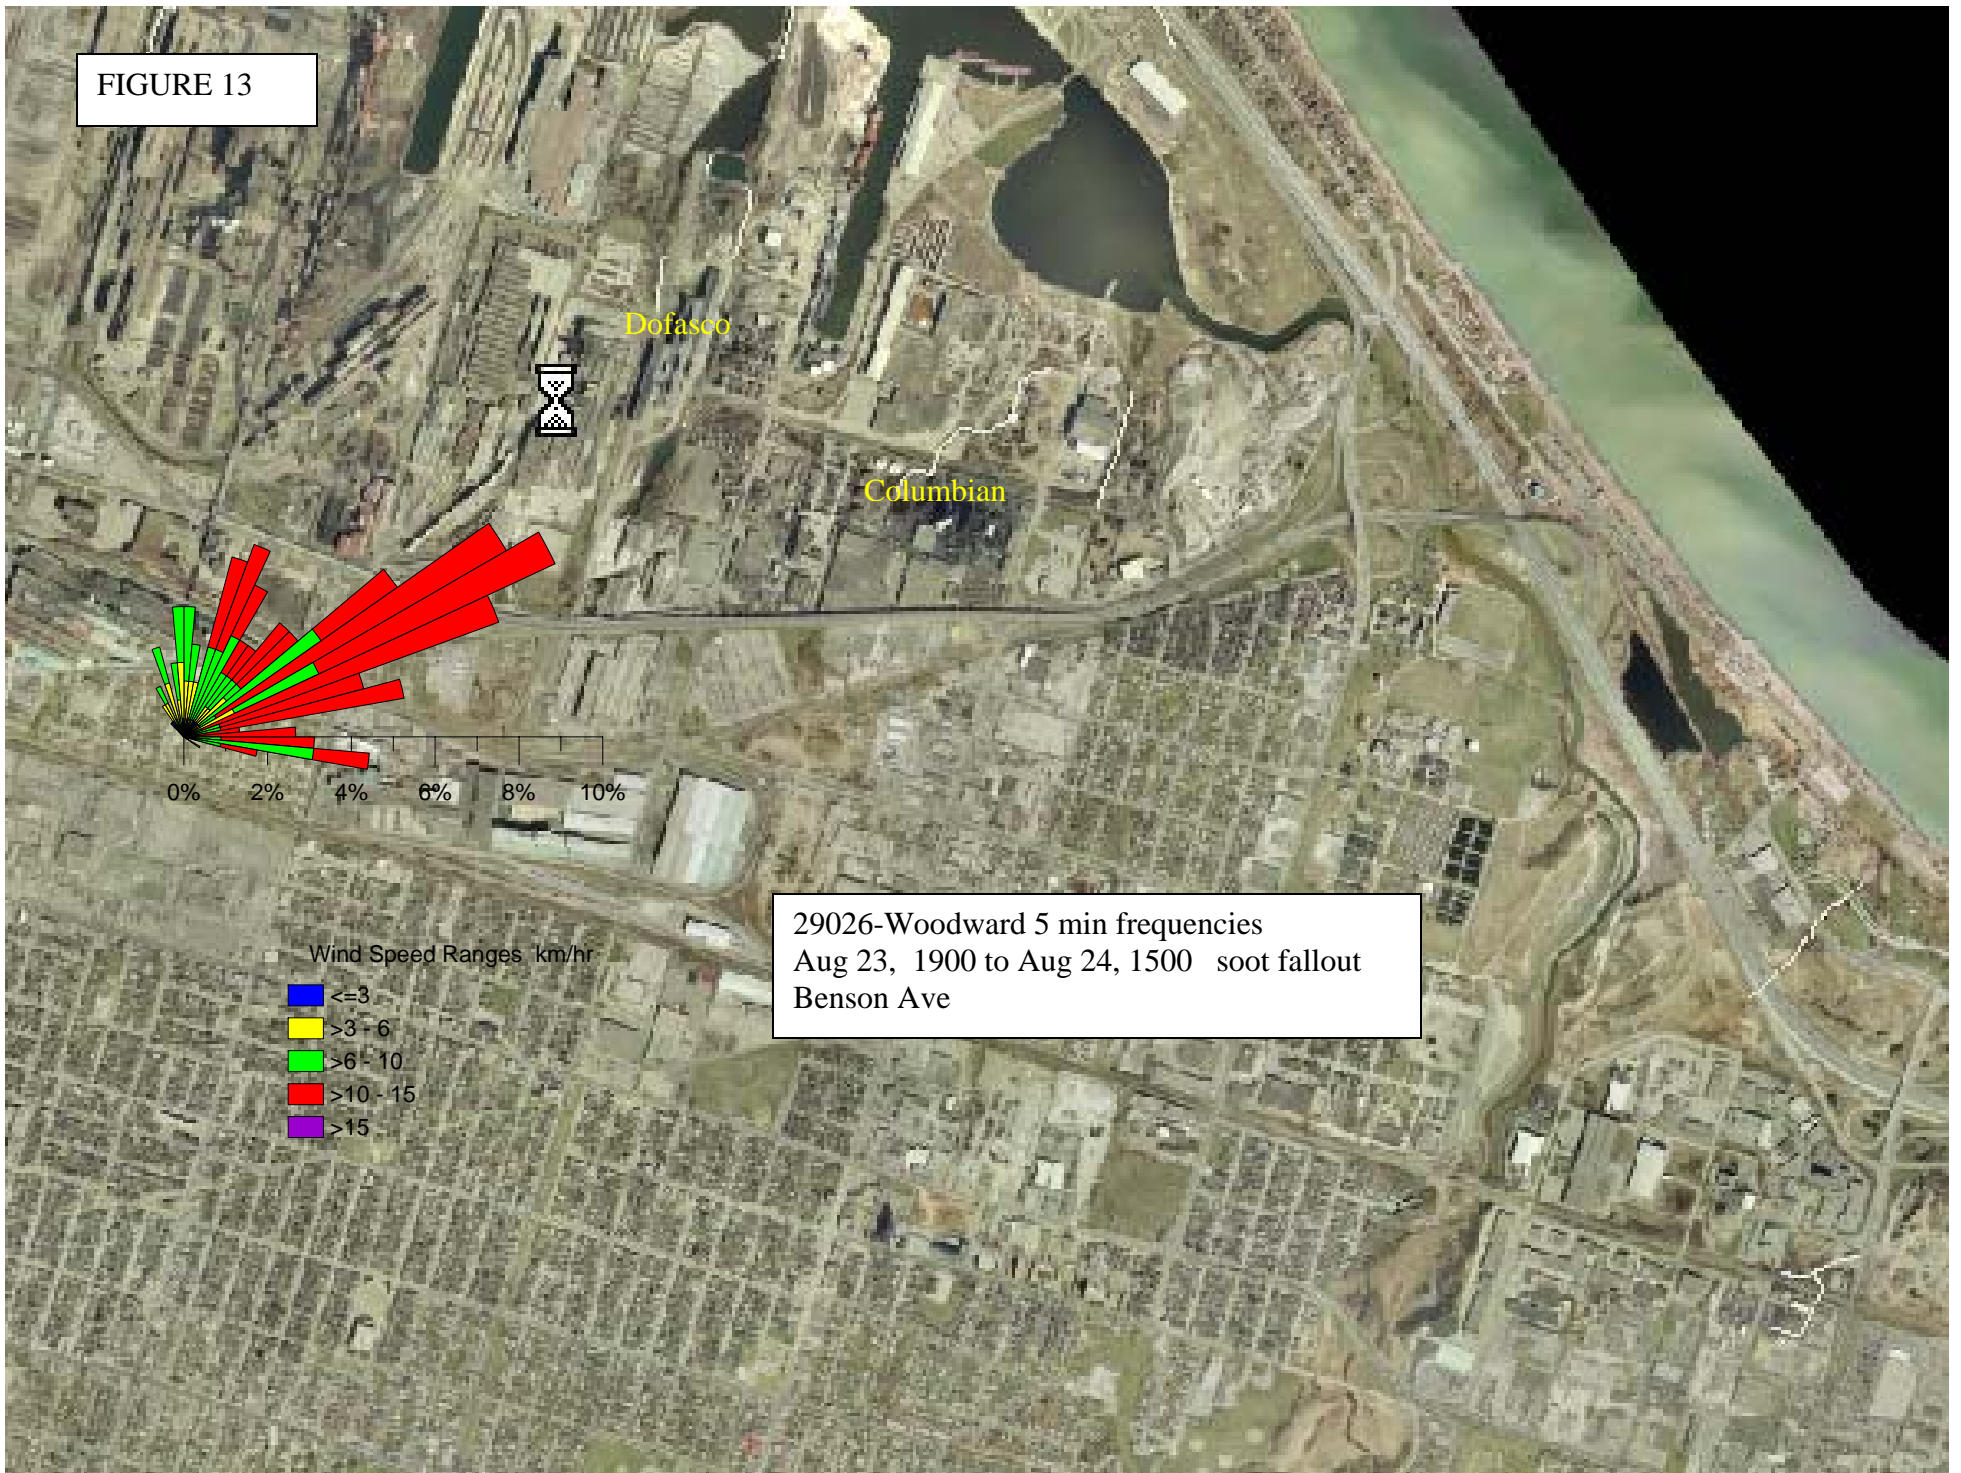
FIGURE 13

The caller advised of soot fallout on Aug 24. Winds had been north or northeast since the previous evening and the wind rose in Figure 13 points at Dofasco and Columbian.

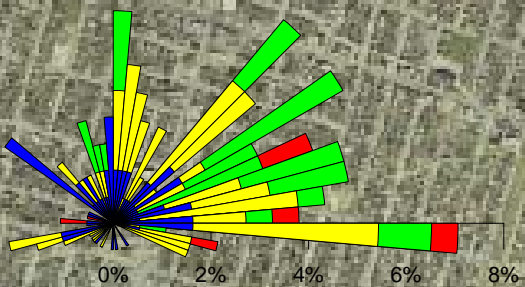
FIGURE 14

The original July 30 event is shown here in Figure 14 as another spatial indication of the event. The same Woodward rose as in Figure 2a is placed onto this address in Figure 14 and points at Columbian, Dofasco and Stelco. The northwest wind bars are not as reliable due to low wind speeds.

29026-Woodward 5 min frequencies
July 29, 1800 to July 30, 1000
Tuxedo Ave N

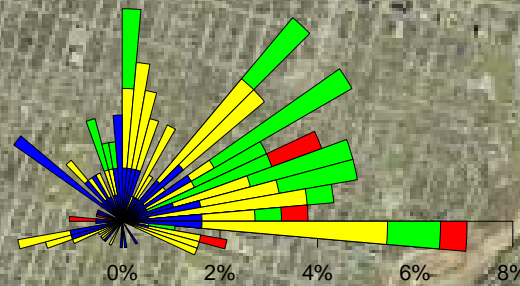
FIGURE 15

The original July 30 event is shown here in Figure 15 as another spatial indication of the event. The same Woodward rose as in Figure 2a is placed onto this address in Figure 15 and points at Columbian, Dofasco and Stelco. The northwest wind bars are not as reliable due to low wind speeds.

29026-Woodward 5 min frequencies
July 29, 1800 to July 30, 1000
Auburn Ave

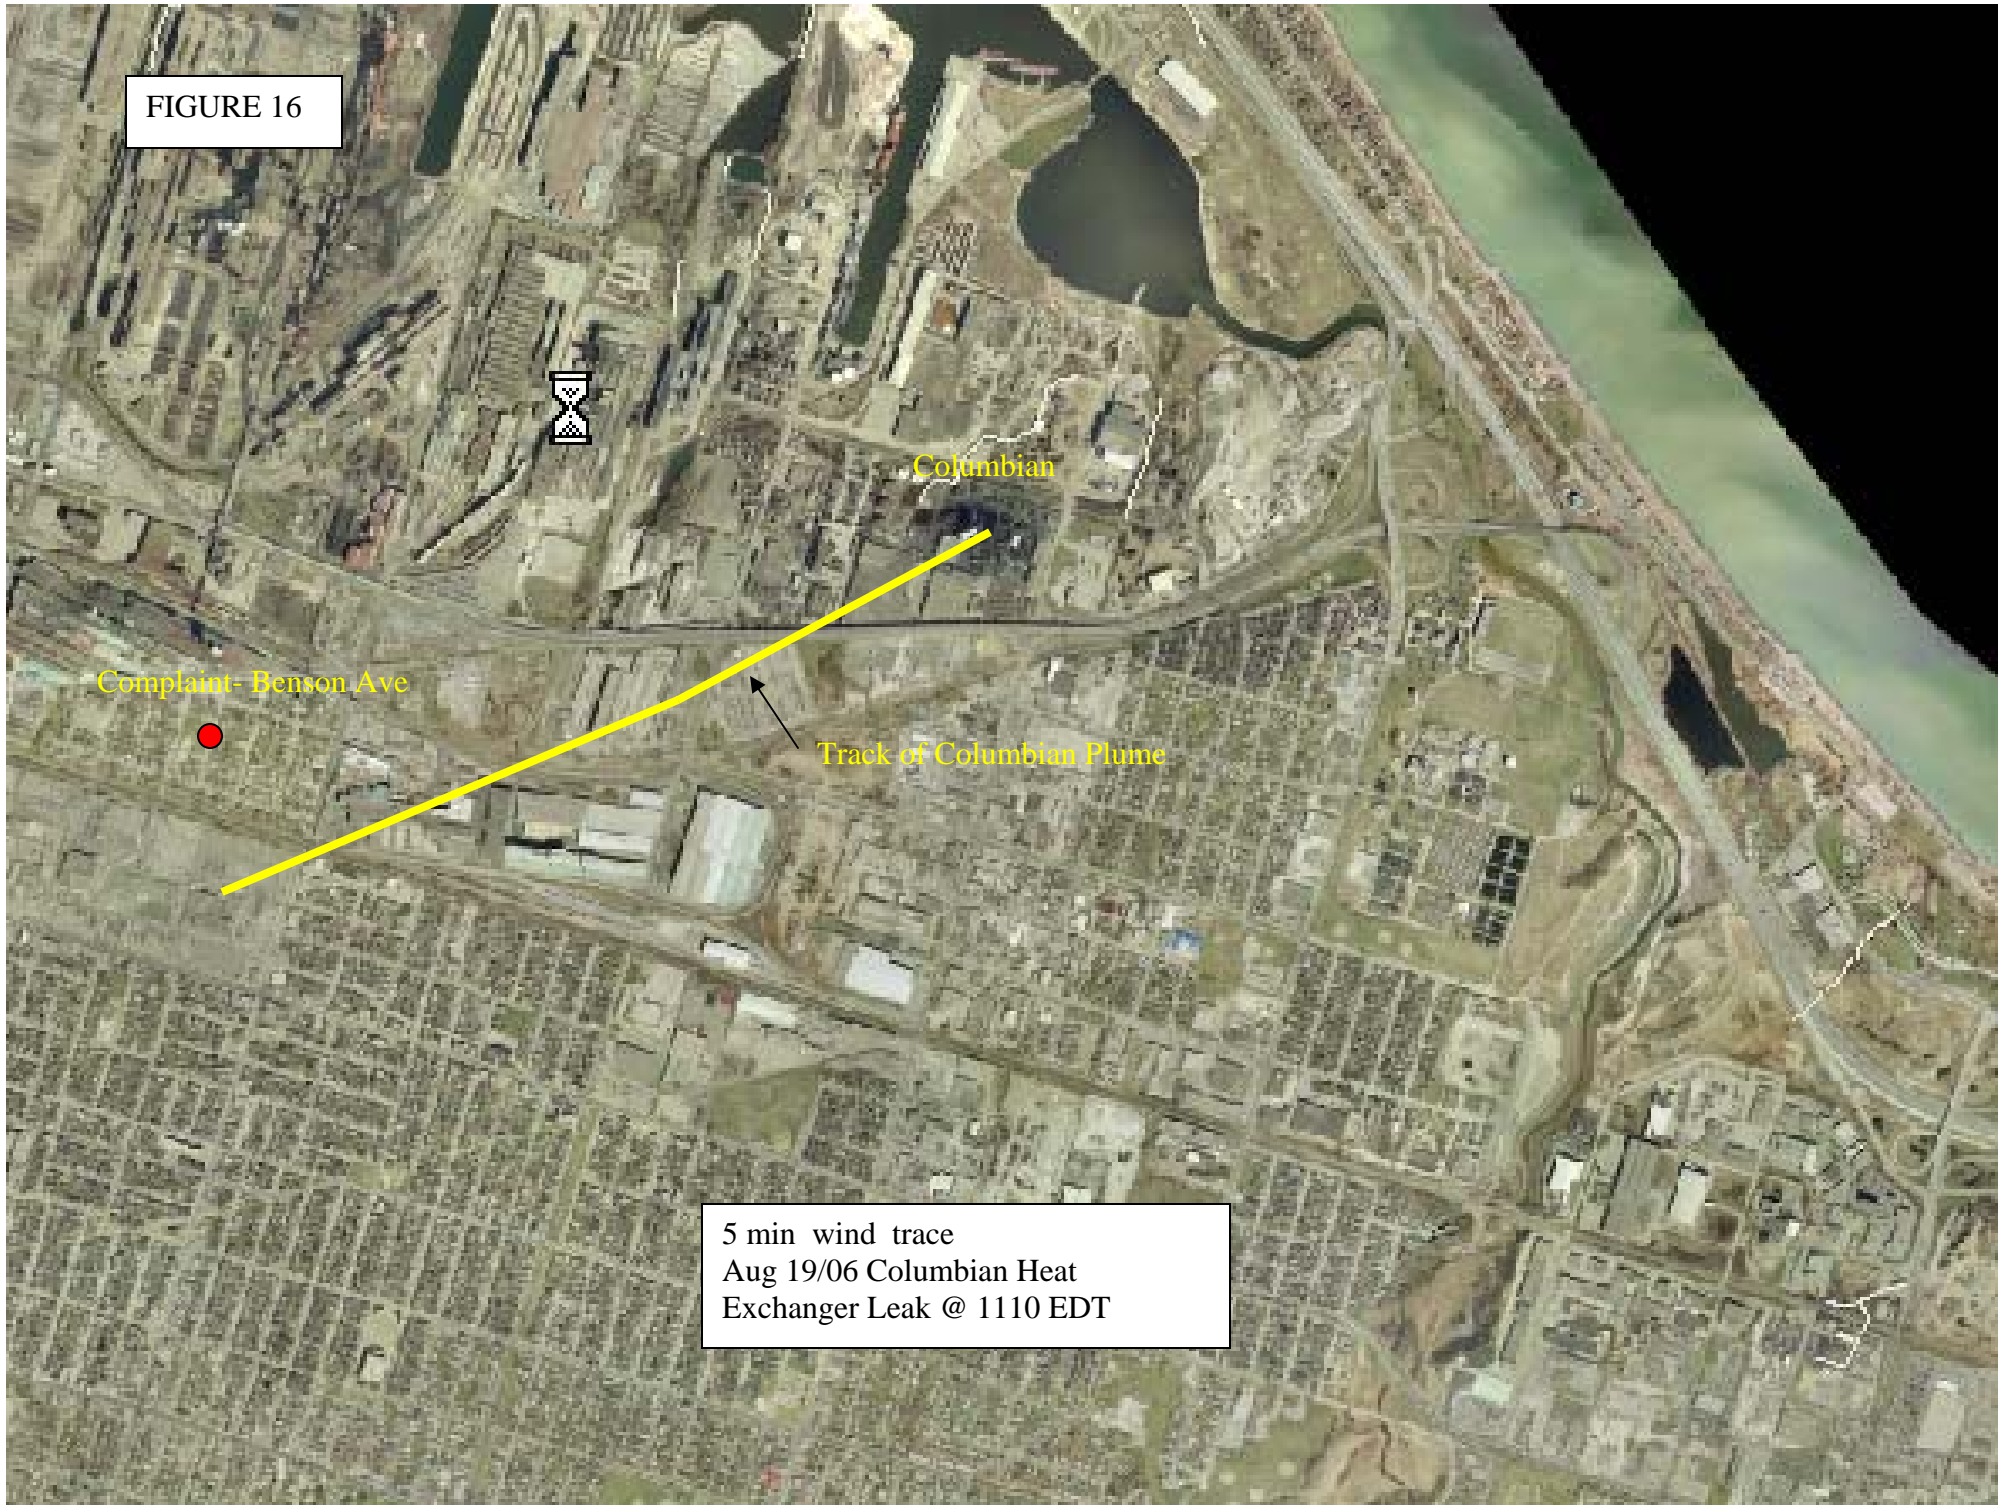
FIGURE 16

On Aug 19, Columbian Chemicals experienced a brief accidental release of carbon black due to a leak at a furnace heat exchanger. The release lasted 10 minutes starting after 11:00 am and was reported promptly by the company to the Ministry. One fallout complaint was subsequently reported from the Benson St area and a fallout samples were later collected by the Ministry at nearby Grenfell Ave. These samples contained 30% coke, 20% carbon black, 5% coal and 5% graphite in one, and the second contained 30% coke, 10% carbon black, and 20% coal. Figure 16 shows the path of release using Woodward 5 minute wind data and the path of travel did go near the complaint area with the leading edge of the plume arriving in about a 10 minutes.

Track of Columbian Plume

5 min wind trace
Aug 19/06 Columbian Heat
Exchanger Leak @ 1110 EDT

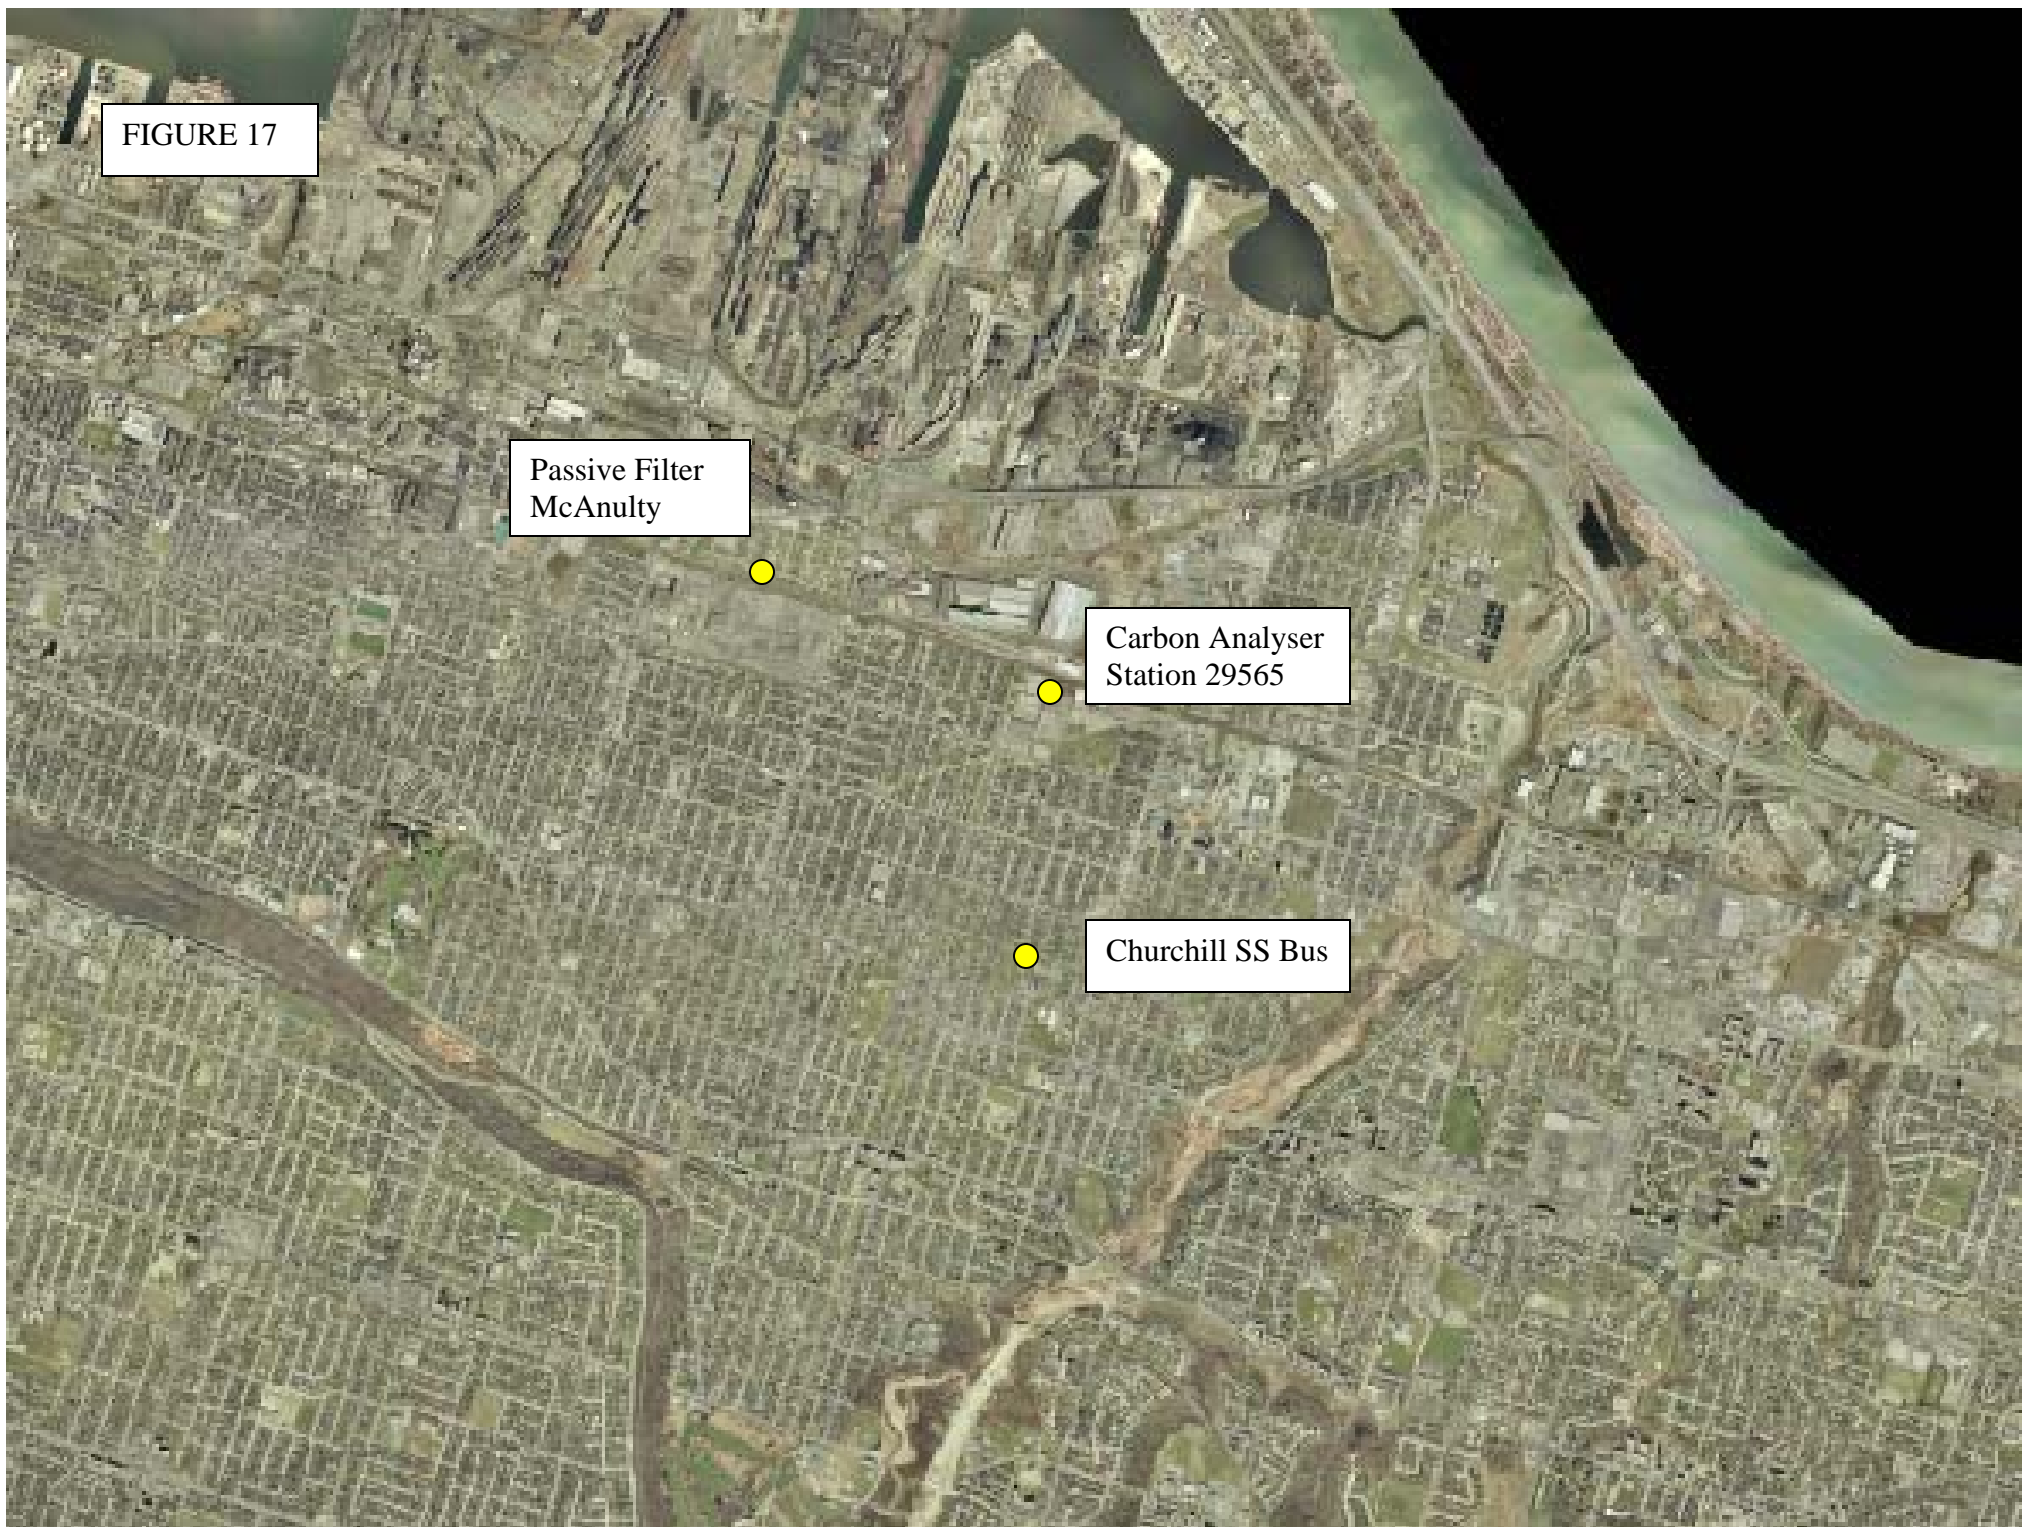
FIGURE 17

In response to this issue, the Ministry has initiated new air sampling in the area to help detect further incidents, should they occur. The locations of these monitors are shown in Figure 17.

- 1) Passive filters – glass fibre filters will be exposed passively (no active air flow) to capture any fallout for microscopic analyses. Initially these were placed at McAnulty Boulevard and will be located at other residences in the neighbourhood upon request. Two samples have been exposed by homeowner to date, one of which was in downwind conditions. Soot and carbon black traces seen. It should be noted that carbon black traces, soots and coal were also seen in *upwind* passive sample.

- 2) Continuous air sampling will be undertaken by the Ministry of the Environment's Environmental Monitoring and Reporting Branch mobile bus. The bus is planned to be stationed at Sir Winston Churchill Secondary School and will measure hourly concentrations of a variety of parameters including particulate matter.

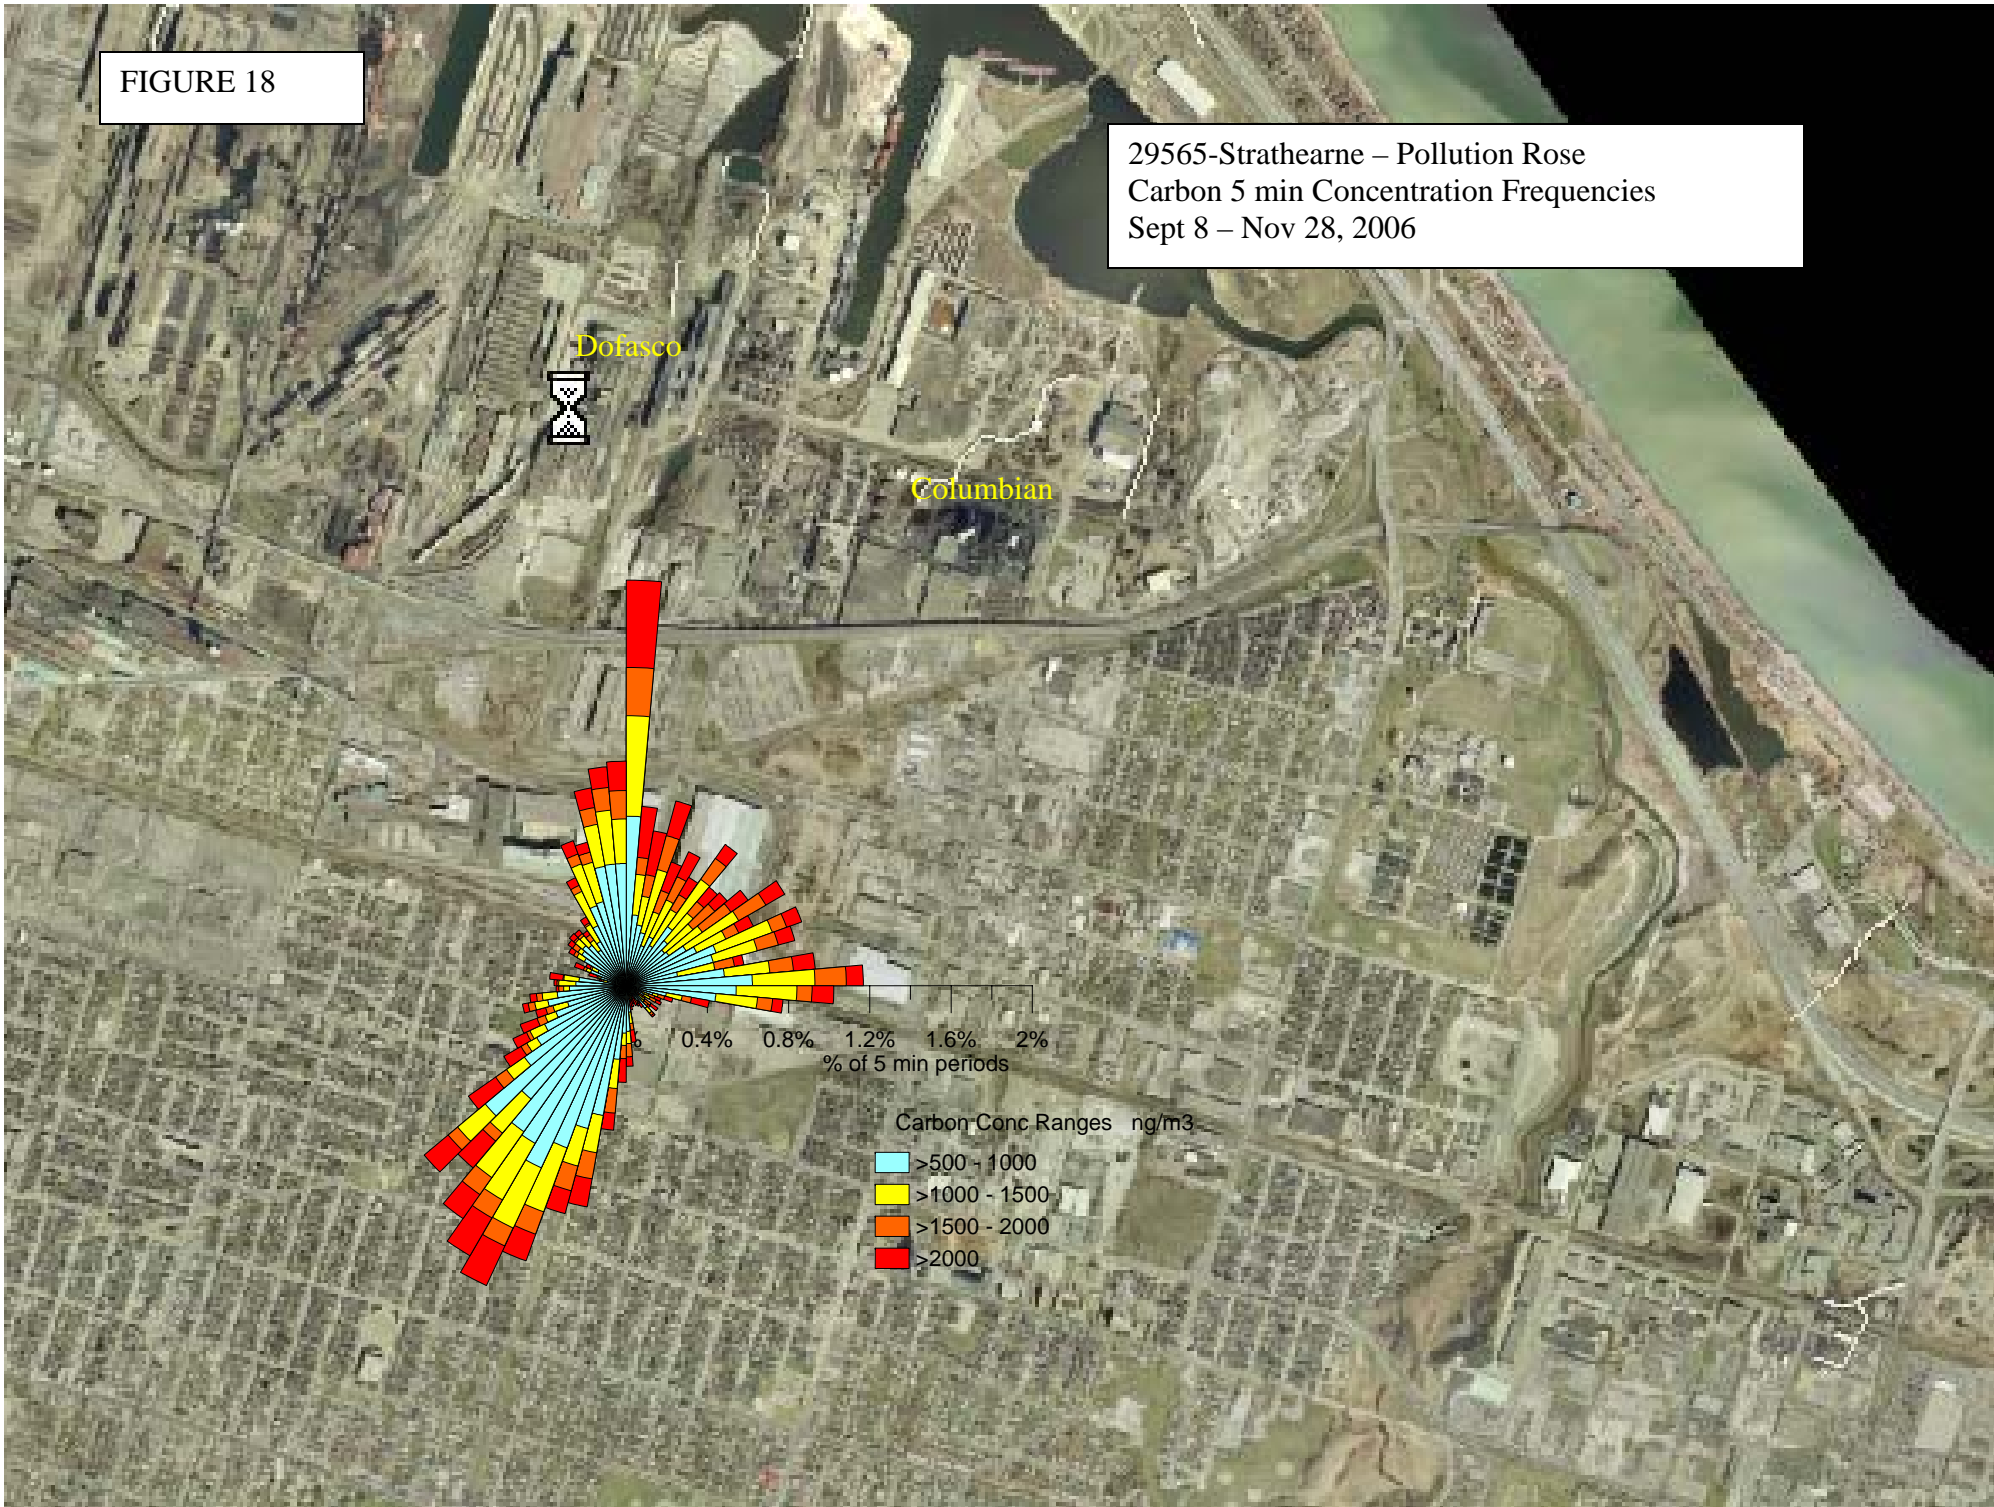
FIGURE 18

- 3) Carbon Analyser – an experimental carbon analyser was installed at HAMN station 29565- Strathearne alongside the PM₁₀ monitor which already operates there. Both instruments are telemetered and provide real time concentration levels of particulate. The carbon analyser is specific to various forms of elemental carbon. The sampler commenced operations on September 8 and the results of the first weeks of operation are illustrated in a pollution rose in Figure 18. The pollution rose is similar to the wind roses presented earlier, with pollutant concentrations instead of wind speeds being classified by wind direction. Highest concentrations to date have occurred with north, east and southwest winds. The highest hourly concentration measured to date has been 3.9 µg/m³. The rose indicates about equal contributions from industrial and non-industrial directions. The elemental carbon concentrations being measured are less than elemental carbon measured in 24 hour exposure filters historically. As such it is uncertain what carbons are being measured. No large peak events have been observed to date.

29565-Strathearne – Pollution Rose
Carbon 5 min Concentration Frequencies
Sept 8 – Nov 28, 2006
